A STUDY OF HIGH POWER ARGON LASER OPTICS

FINAL REPORT

Contract NAS 12-548

RAYTHEON COMPANY
Research Division
Waltham, Massachusetts

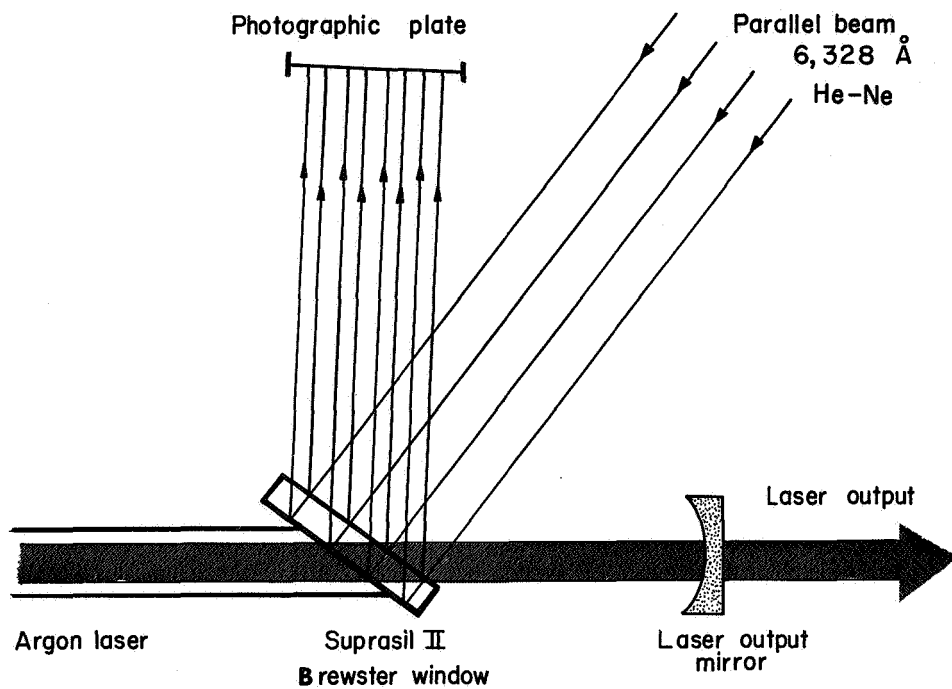
FIGURE 10

An interference pattern consisting of parallel light and dark bands can be obtained from the reflection of the two flat, but not necessarily parallel window surfaces. Any variation from flatness on one of the window surfaces will appear on the interferogram as a bending of the bands in the area concerned. Interferograms obtained from a window mounted on the principal laser are displayed in Fig. 11. The rectangular flat was mounted on a tube which was cut at Brewster's angle. The contact area when viewed normal to the flat appears as an ellipse about 15 mm by 25 mm. The photograph labeled "Laser Off" in Fig. 11 depicts an interferogram obtained from an undistorted flat; the dark elliptical band marks the contact region. A surface distortion which developed in the first minute of laser operation is clearly visible in the center photograph. After 35 minutes of operation a severe, localized distortion had developed, as indicated by the bottom photograph.

Analysis of the nature and location of the interferogram pattern established that the distortion was a local lenticular deformation of the inner surface of the flat. The output power decay and beam distortion shown in Figs. 1 and 2 were observed to correlate with this deformation of the window. When lasing was interrupted, the deformation relaxed but returned rapidly when the beam was re-established, accompanied by the sequence of changes in the output beam characteristics. However, if the degraded window is removed from the system and reversed, no such rapid power decay occurs; the long-term decay only commences after the fresh surface has been exposed to the discharge for some length of time. Tests were made with windows which previously had both surfaces, in turn, exposed to the discharge. Interferograms showed in each test that only the inside surface exposed to the low pressure discharge environment deformed. At no time was bulk heating of the window observed. Further experiments with a second Brewster window completely inside the vacuum envelope again confirmed the observation that the degradation and associated deformation were localized at or near the surface of that window exposed to the discharge region.

ARRANGEMENT OF APPARATUS FOR OBTAINING SHEARING
INTERFEROGRAMS OF BREWSTER ANGLE WINDOW

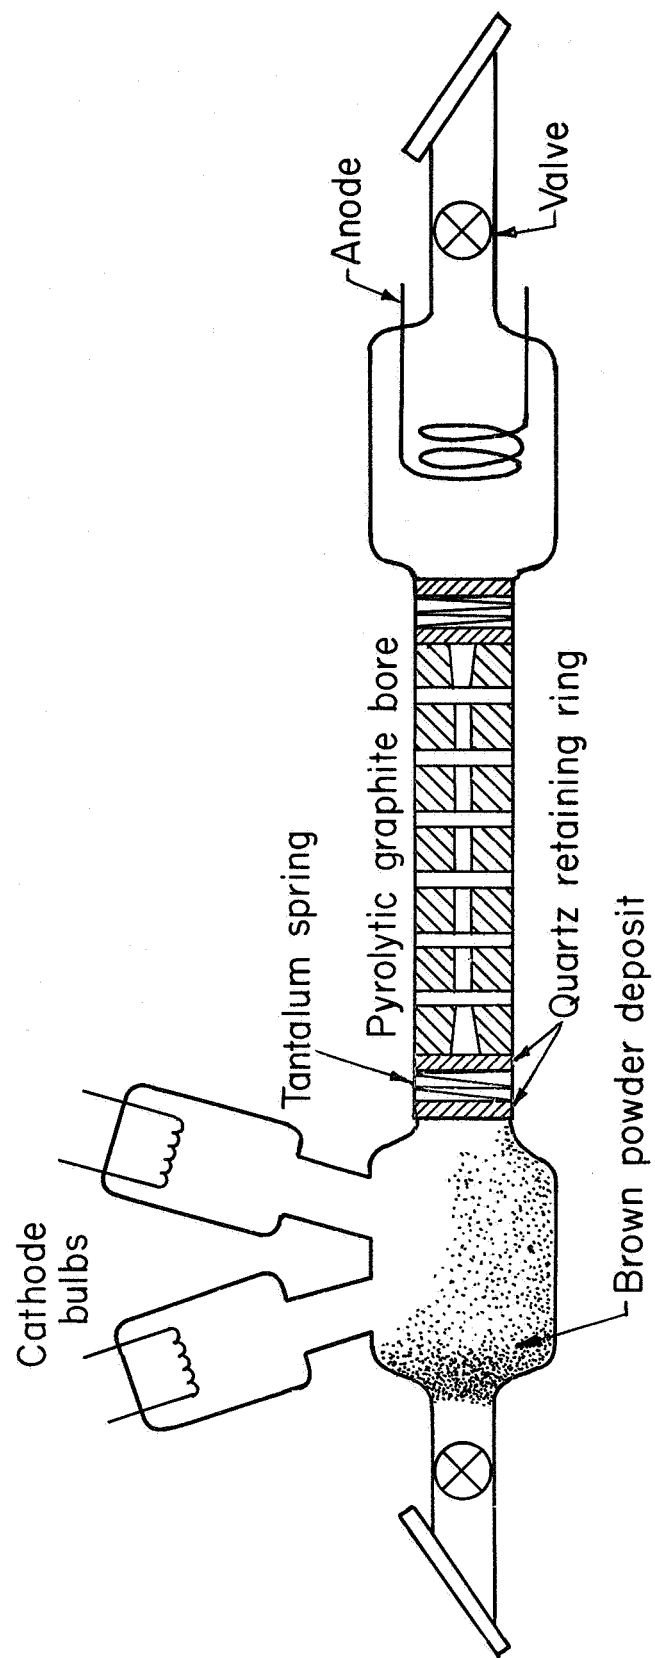
FIGURE 17

A brownish deposit accumulated on the walls of the bulbous section at the cathode end of the pyrolytic graphite bore laser as indicated in Fig. 17. When a modification of the structure was made, this material was removed and proved to be powdery in composition. This powder deposit had slowly accumulated during the previous eight months of laser operation. Samples of this powder were analyzed with the electron beam microprobe. The analysis revealed that some particles showed only the presence of silicon, while others contained no silicon but instead many other metallic elements. Listed in order of decreasing amounts, these elements were: Ba, Fe, Mn,

SCHEMATIC DIAGRAM OF PYROLYTIC GRAPHITE BORE LASER

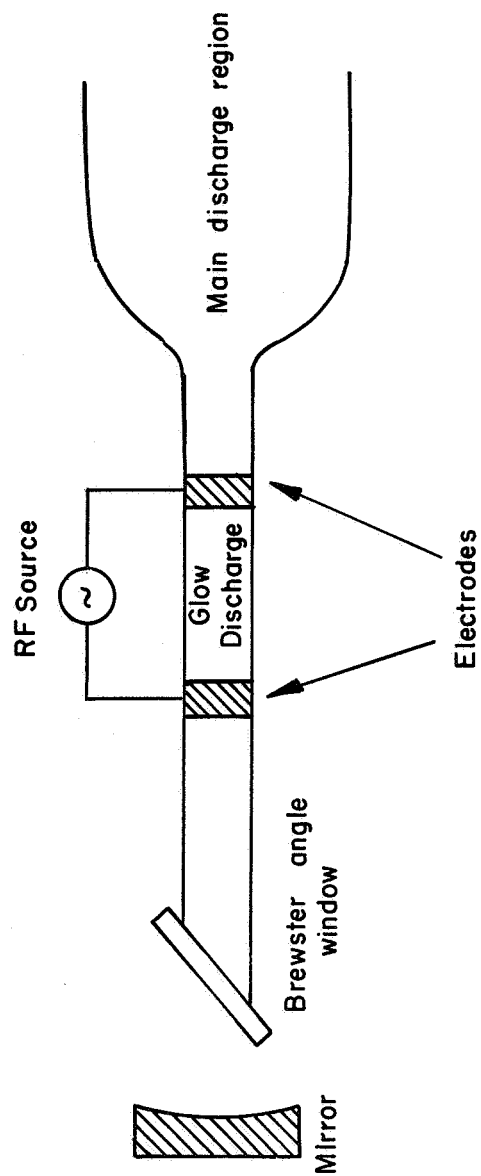
FIGURE 23

RF DISCHARGE USED FOR THE RESTORATION OF TERMINAL OPTICS

This result was followed up using a more refined method establishing the rf discharge, in which the rf was applied between an external electrode around the tube, located a few centimeters from the window, and the flange while the laser was operating as is shown in Fig. 23. A dramatic cleanup of the window (Fig. 24) was observed within the first minute after initiating the rf discharge. Further tests with the rf technique, which had no adverse effects on the output during the application time, indicated that re-establishment of the window film was inhibited particularly with high discharge current and high optical power operation.
